# RESEARCH MEMORANDUM

CYCLIC ENGINE TEST OF CAST VITALLIUM

TURBINE BUCKETS - II

By J. Elmo Farmer, George C. Deutsch  
and Paul F. Sikora

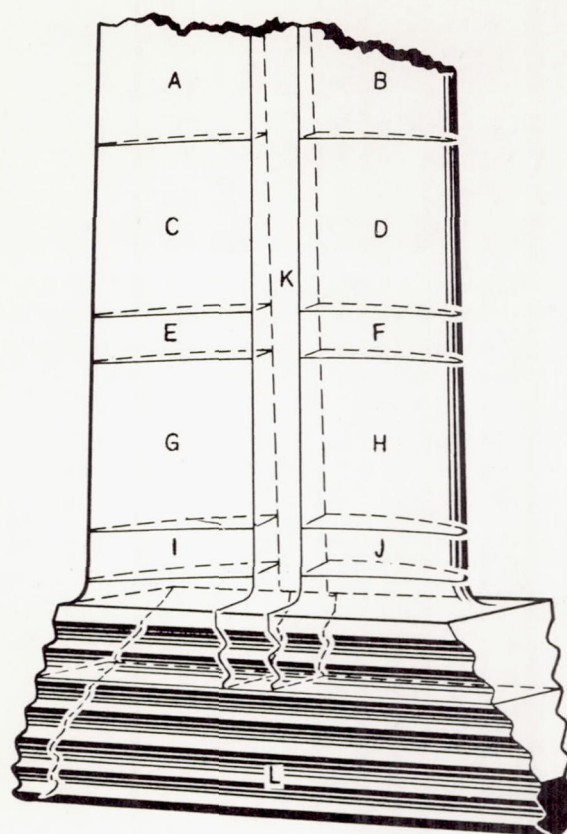
Macroexamination. - The buckets were electrolytically etched in 10-percent hydrochloric acid to reveal the macrostructure. Grain-size measurements were made at six representative positions (A, B, E, F, I, and J, fig. 1) on the blade surface. The standard A.S.T.M. grain-size procedure was followed except that a magnification of unity was used instead of the usual 100X. It was noted whether the fracture being examined was intercrystalline or transcrystalline.

Microexamination. - The blade areas of both the broken and the unbroken buckets were sectioned as indicated in figure 1. Sections A and B were polished for metallographic examination in both the longitudinal and the transverse directions, together with the top transverse surfaces of sections E, F, I, and J. The samples were electrolytically etched in aqueous hydrochloric acid. The transverse samples were rated for carbide-mesh distribution by measuring the number of carbide-island intersections encountered on eight random lines, each 1 inch long at a magnification of 100X. The average of the eight values thus obtained was called the carbide-mesh number.

Figure 1. - Diagram showing manner in which buckets were sectioned to permit metallurgical examination.

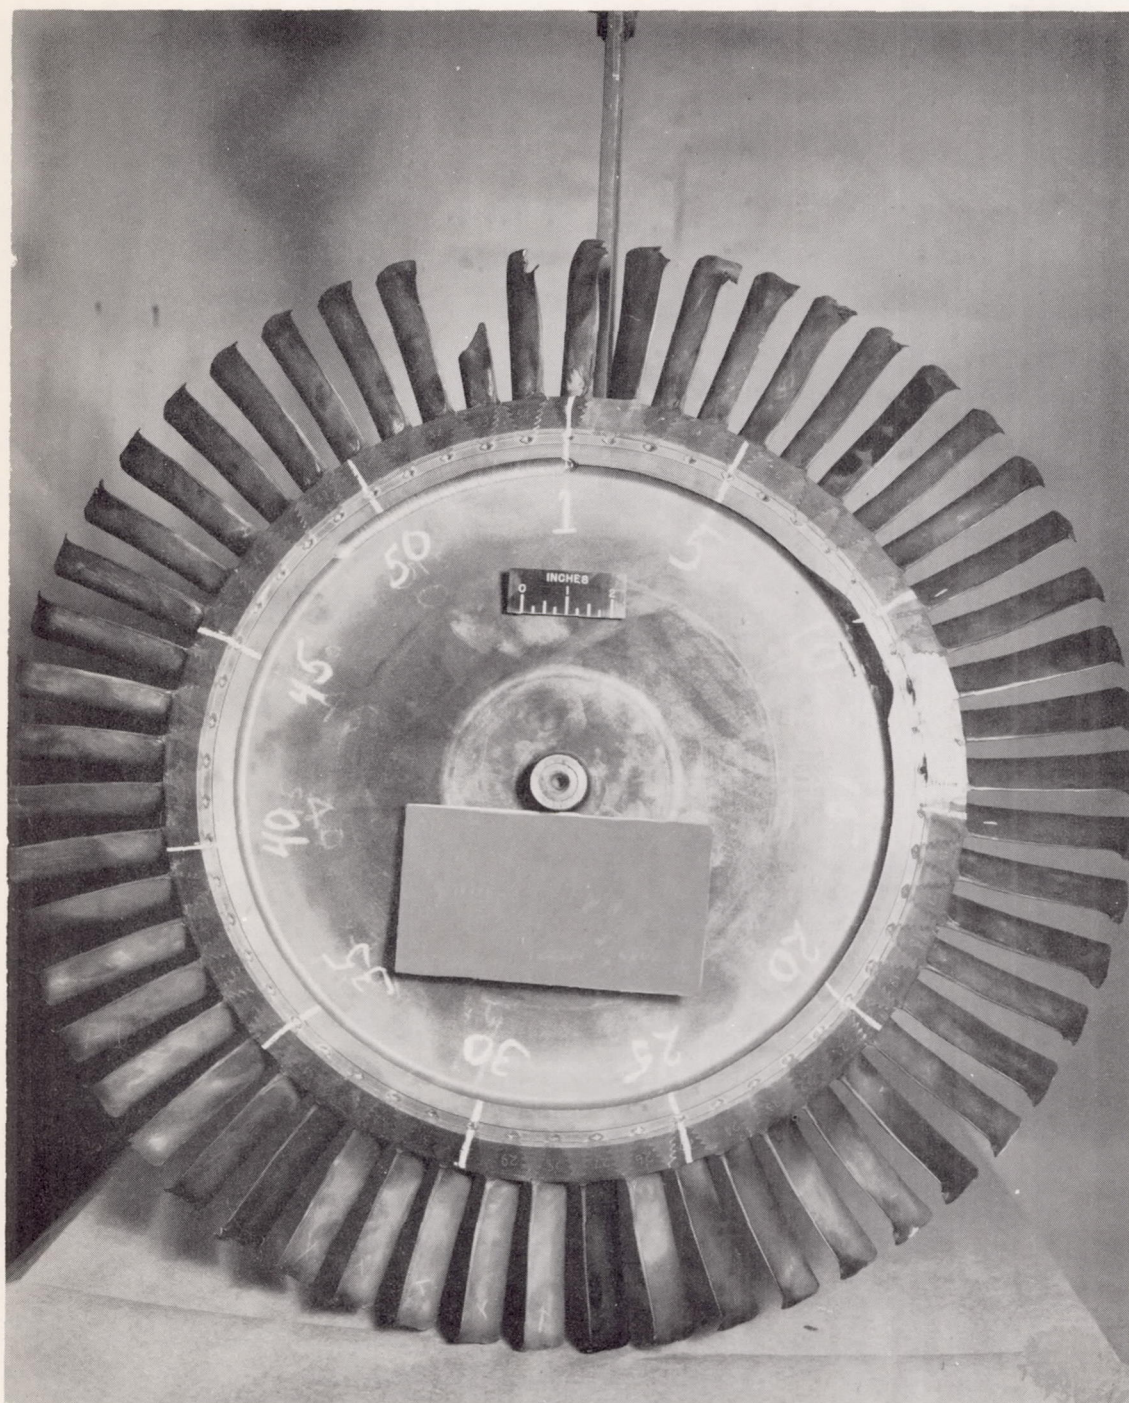
Wheel 1. - The first and second bucket failures, in cycle 22 at 7 hours and 20 minutes and in cycle 25 at 8 hours and 12 minutes, respectively, are described in reference 1. The third bucket, 1-53, broke in cycle 26 at a total running time of 8 hours and 34 minutes (fig. 2).

Figure 2. - Wheel 1 after third bucket failure (bucket 1-53) during cycle 26 at total running time of 8 hours and 34 minutes.

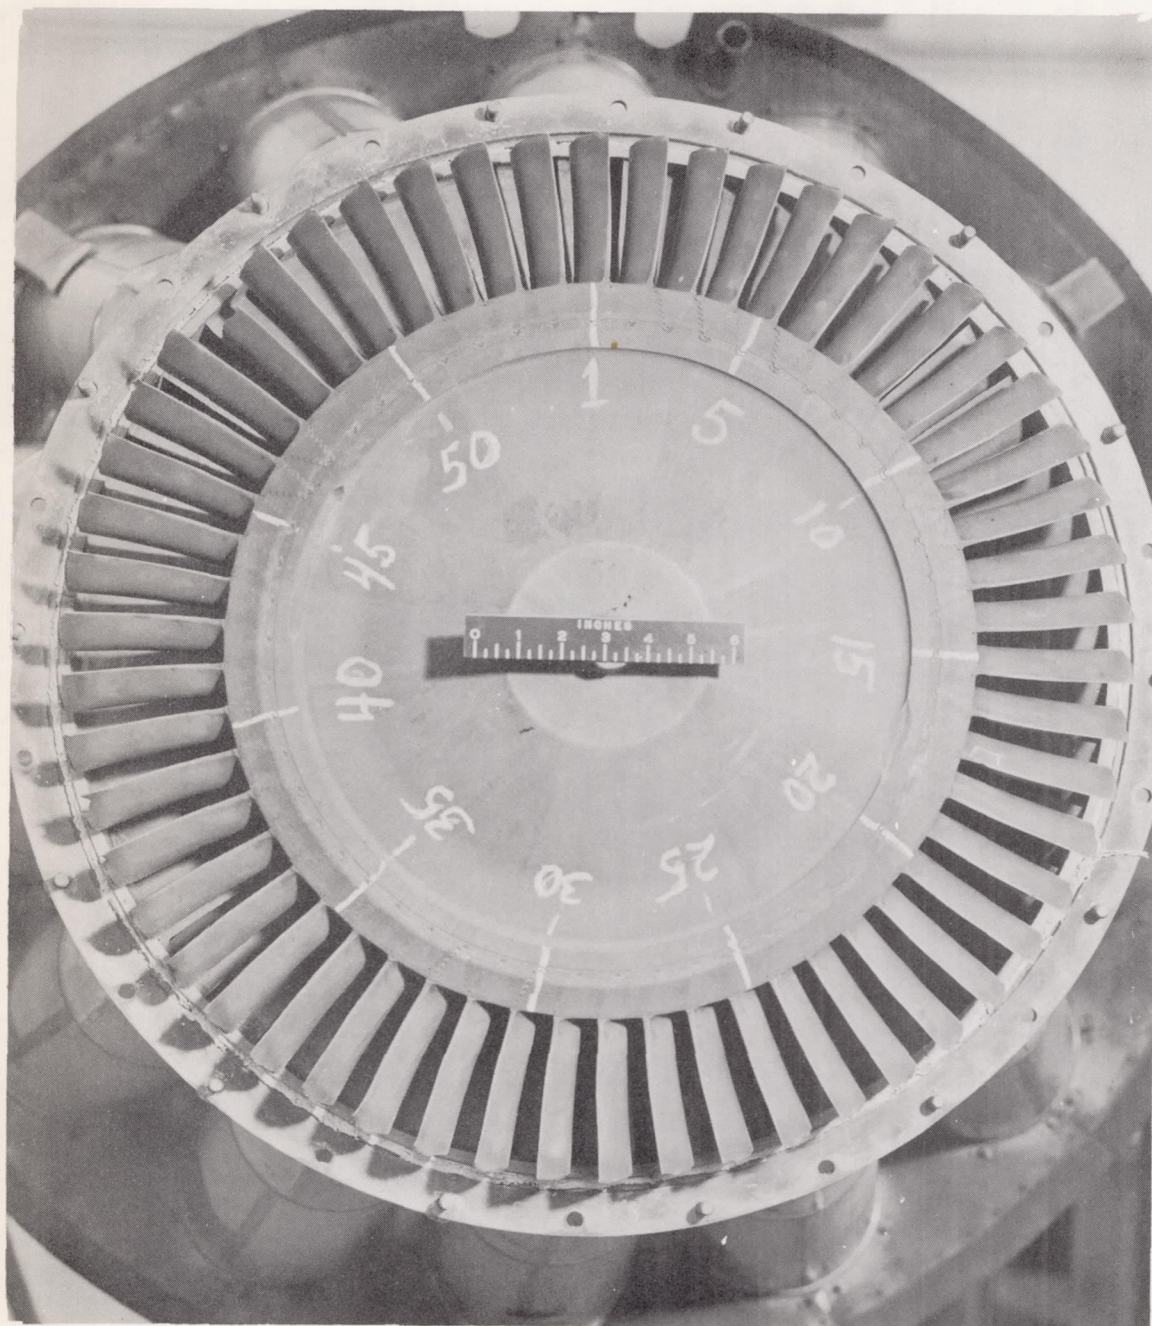
Wheel 2. - The first bucket failure (bucket 2-18) occurred in cycle 29 at 9 hours and 28 minutes (reference 1). The second bucket, 2-48, broke in cycle 106 at a total running time of 35 hours and 10 minutes (fig. 3).

Figure 3. - Wheel 2 after second bucket failure (bucket 2-48) during cycle 106 at total running time of 35 hours and 10 minutes.

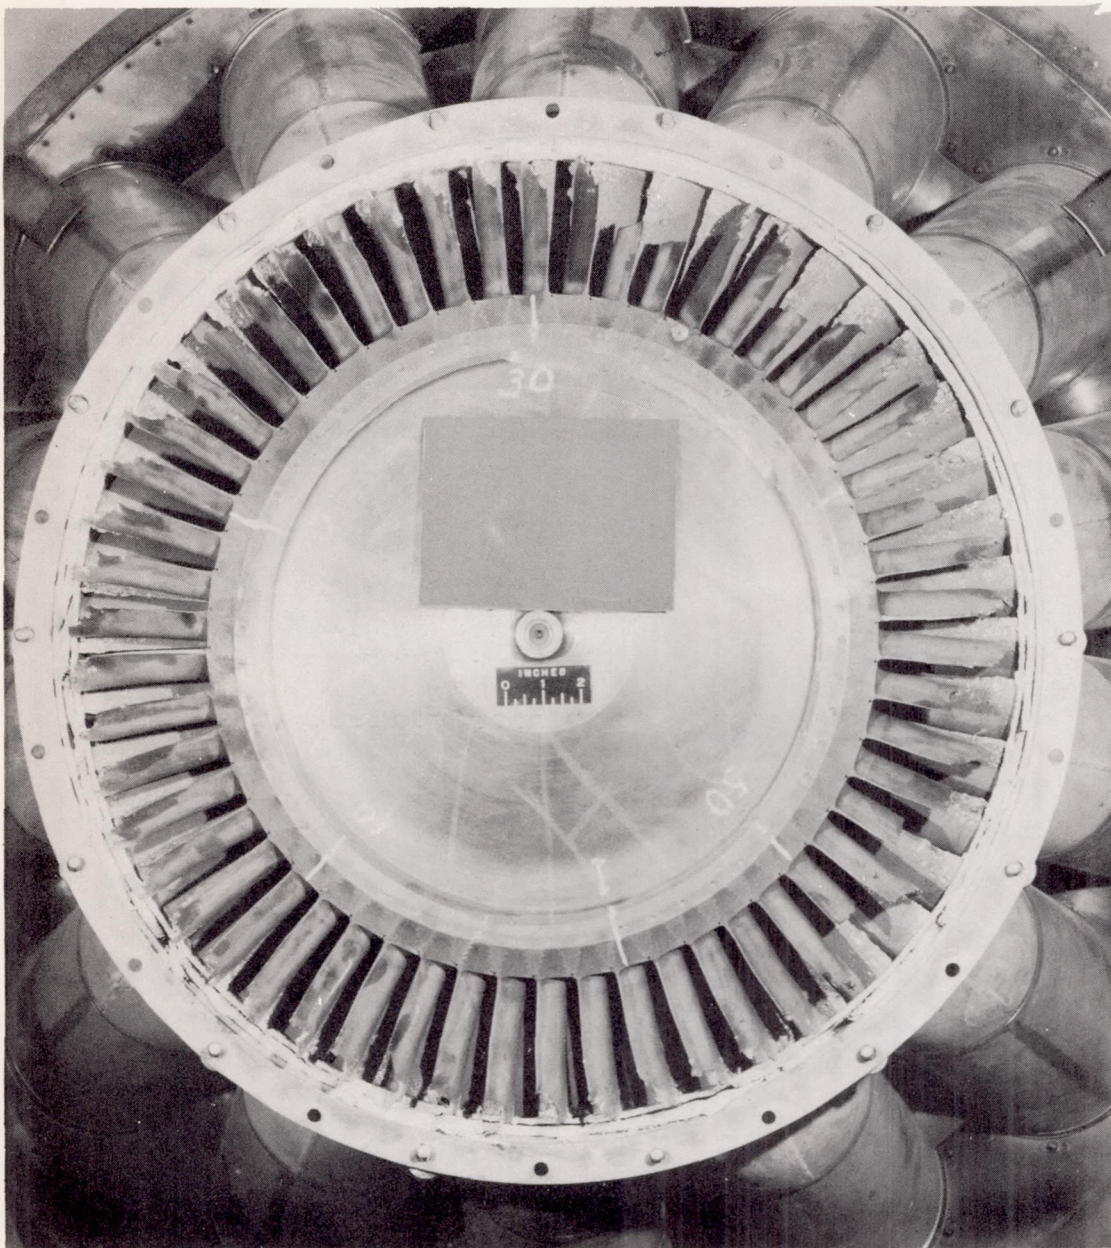
Wheel 3. - Buckets 3-16 and 3-43 were removed for examination after cycle 229 at 76 hours and 20 minutes total running time. Two new buckets were installed, the wheel balanced and the running continued. Upon inspection after cycle 260 (86 hr, 40 min, total running time), bucket 3-34 was found to be cracked on the convex surface. This bucket was replaced, the wheel balanced, and the running continued. In cycle 268 (89 hr, 17 min), a failure occurred that broke eight buckets and so damaged the others that running could not be continued with this wheel (fig. 4). Four of the eight broken buckets (3-33, 3-36, 3-45, and 3-49) were removed for examination.

Figure 4. - Wheel 3 after second bucket failure occurred during cycle 268 at total running time of 89 hours and 17 minutes damaging eight buckets.

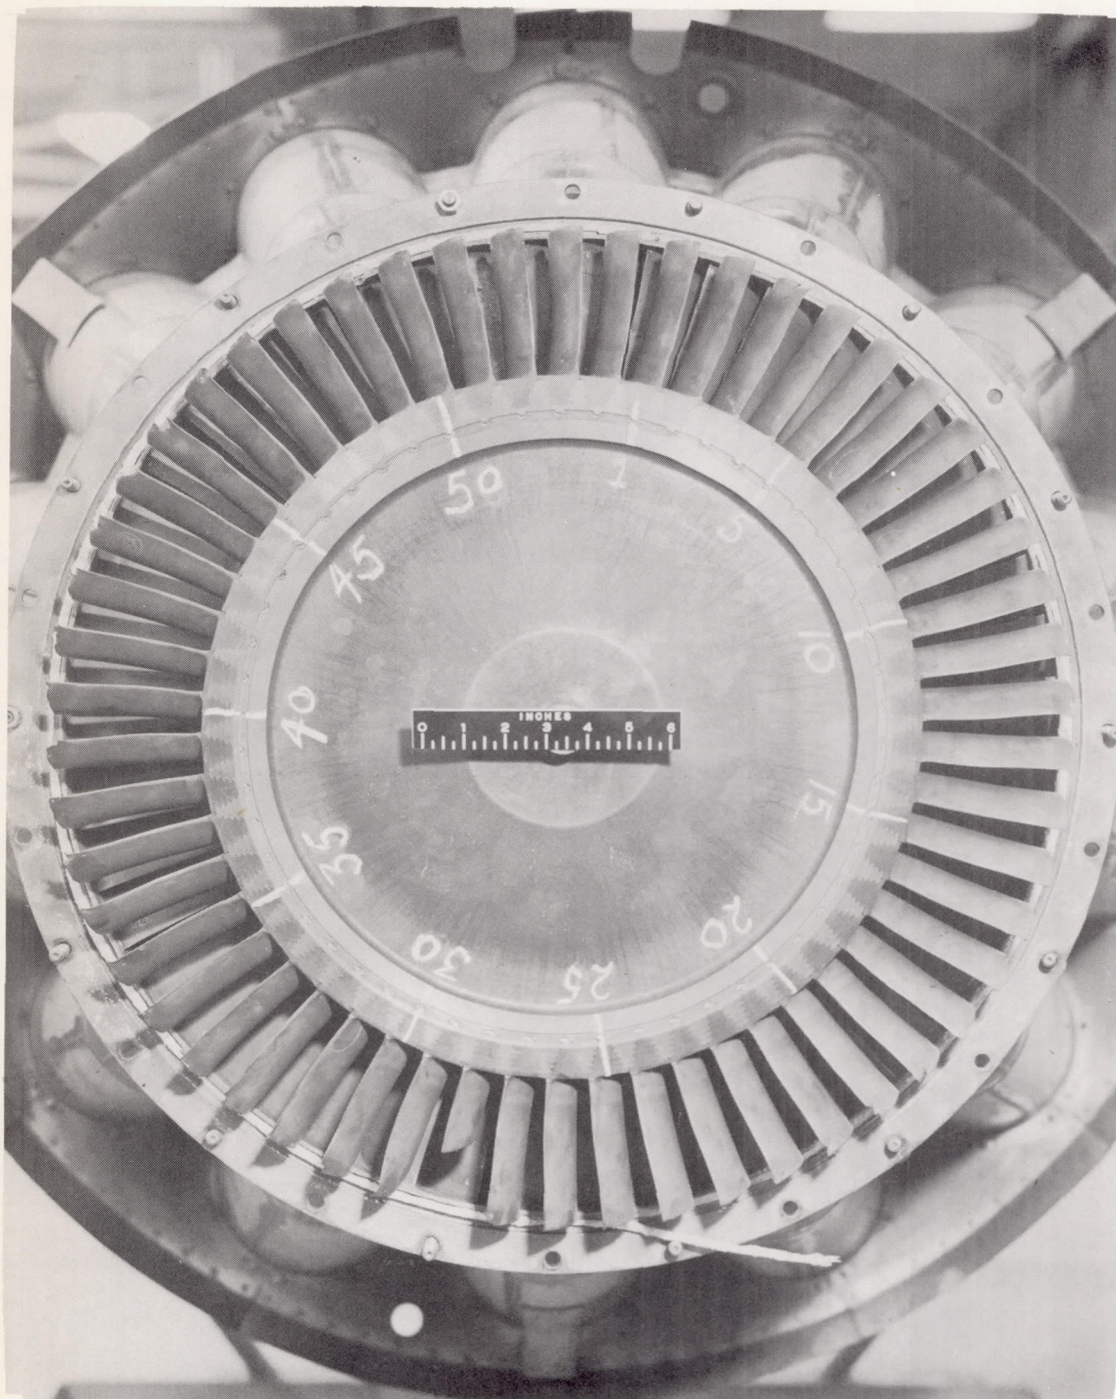
Wheel 4. - The first bucket, 4-28, failed in cycle 156 at a total running time of 51 hours and 57 minutes (fig. 5). The broken bucket and two unbroken ones, 4-1 and 4-29, were removed from the wheel for examination. Three new buckets were installed, the wheel balanced, and the running continued. In cycle 188 (62 hr, 37 min, total

Figure 5. - Wheel 4 after first bucket failure (bucket 4-28) during cycle 156 at total running time of 51 hours and 57 minutes.

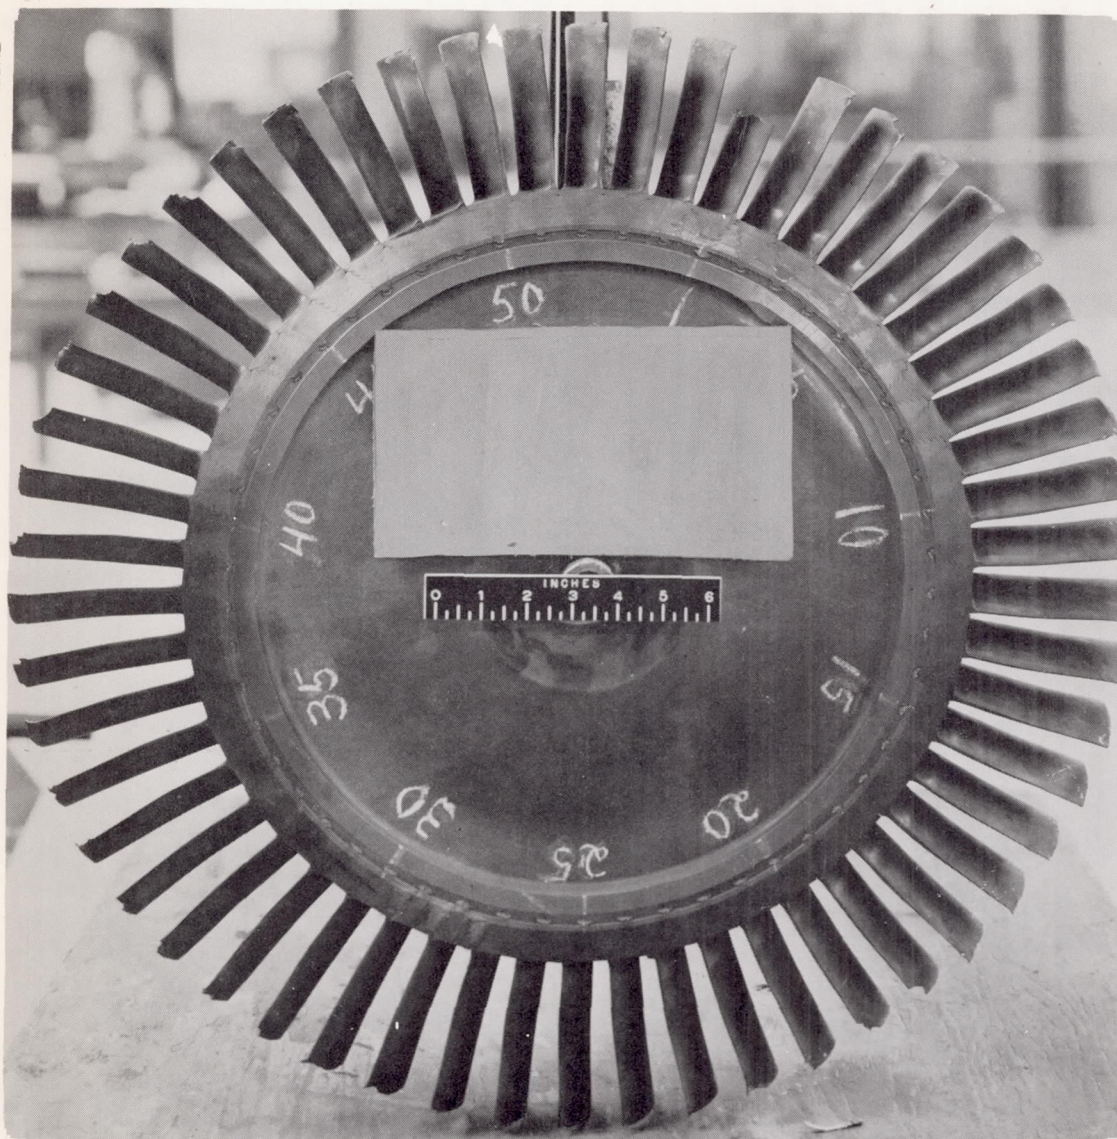
running time), bucket 4-1A broke. This bucket (fig. 6) was one installed after the first failure and had been operated for 32 cycles (10 hr, 40 min). The bucket was replaced, the wheel balanced, and the running continued. The third bucket, 4-39, broke during cycle 190 at a total running time of 63 hours and 16 minutes (fig. 7).

Figure 6. - Wheel 4 after second bucket failure (bucket 4-1A) during cycle 188 at total running time of 62 hours and 37 minutes. This bucket was installed after first bucket failure and was run 32 cycles (10 hr, 40 min).

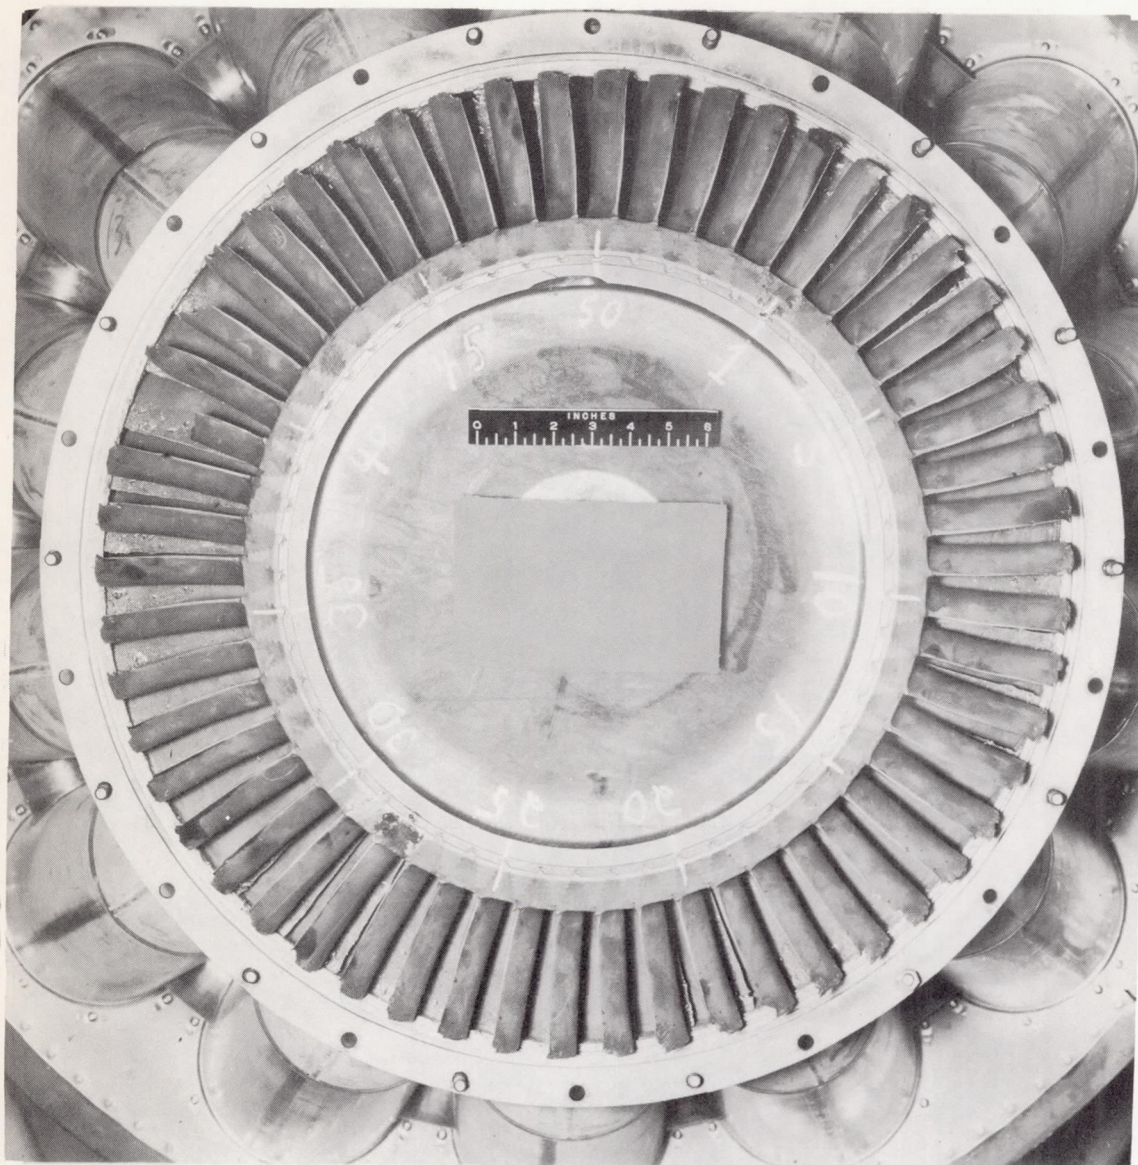
Figure 7. - Wheel 4 after third bucket failure (bucket 4-39) during cycle 190 at total running time of 63 hours and 16 minutes.

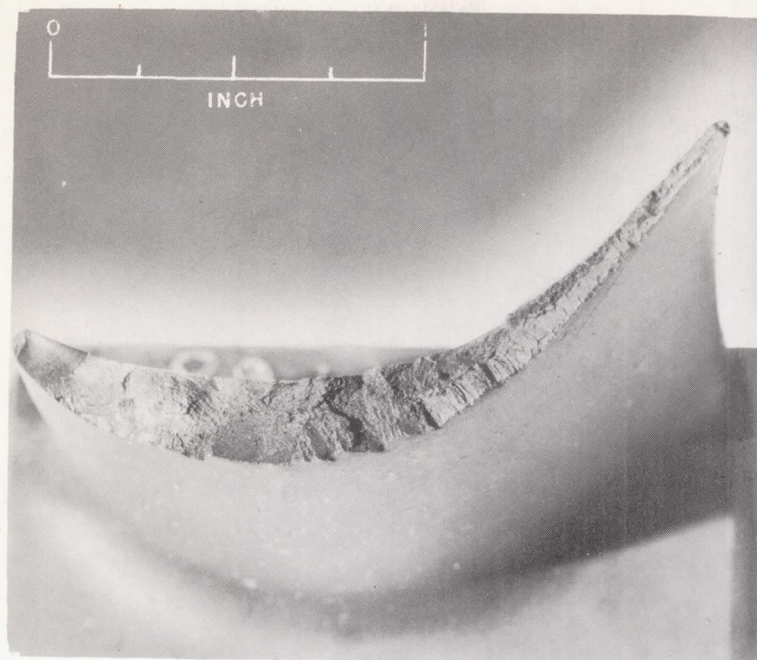
3. Appearance of the fracture faces of broken buckets permitted classification of the failures into primary and secondary failures, examples of which are shown in figures 8(a) and 8(b), respectively.

4. The fracture faces of the eight primary-failure buckets exhibited three distinct zones that are quite different in appearance (fig. 8(a)). One zone has a smooth appearance and is coated with a tight oxide film ranging in color from light straw to dark gray. Contrary to data presented in reference 1, this zone occurred randomly at either edge and in one case at the center of the bucket. This apparent discrepancy in the results was probably caused by the increased number of buckets examined in this investigation. The second zone had the fibrous appearance that is characteristic of fractured ductile material and was coated with a loose porous oxide film ranging in color from a deep blue to dull gray or black. The third zone was a transitional one between the other two zones both in location and in characteristics. Fractures of the primary class were transcrystalline across the entire bucket and occurred in the center third of the blade length (fig. 9(a)). These observations lead to the conclusion that the primary type of failure is caused by fatigue, which originates in the smooth zone and progresses until the centrifugal stress on the remaining portion of the blade exceeds the ultimate strength of the material and the blade fails in tension. The location of the origin of fatigue within the smooth zone was extremely difficult to determine, particularly because the fractured surface was always coated with a thick oxide layer, which was difficult to remove by methods that did not damage the fracture face.

(a) Primary failure,  
caused by fatigue.

Figure 8. - Fractured faces of primary and secondary types of turbine-  
bucket failure.

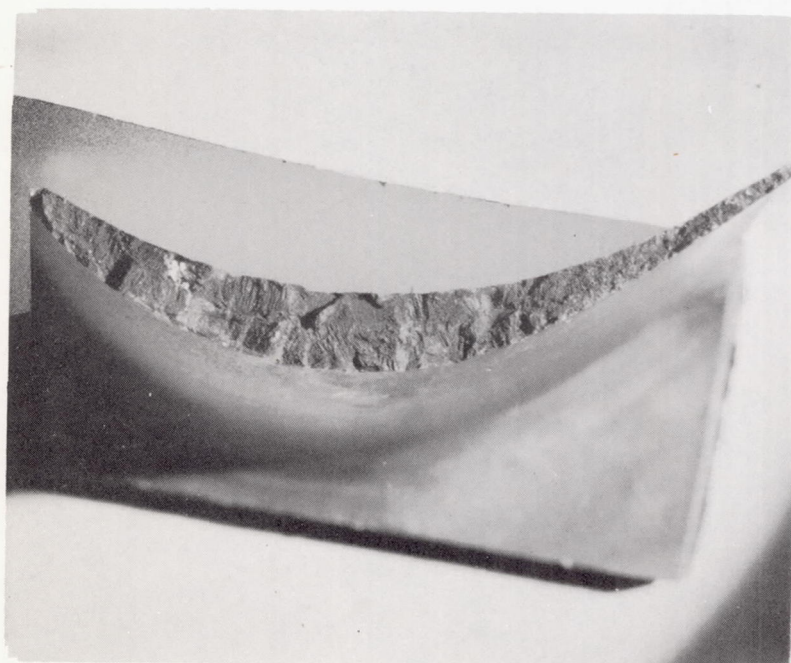
5. The fractured faces of four buckets representative of the secondary type of failure (fig. 8(b)) exhibited an appearance, uniform across the entire bucket, that was similar both in color and in texture to the fibrous zone previously described. This type of failure was also transcrystalline and had a random distribution along the blade length (fig. 9(b)). These failures probably occurred upon impact with segments of other broken buckets.

(b) Secondary failure, probably  
caused by impact.

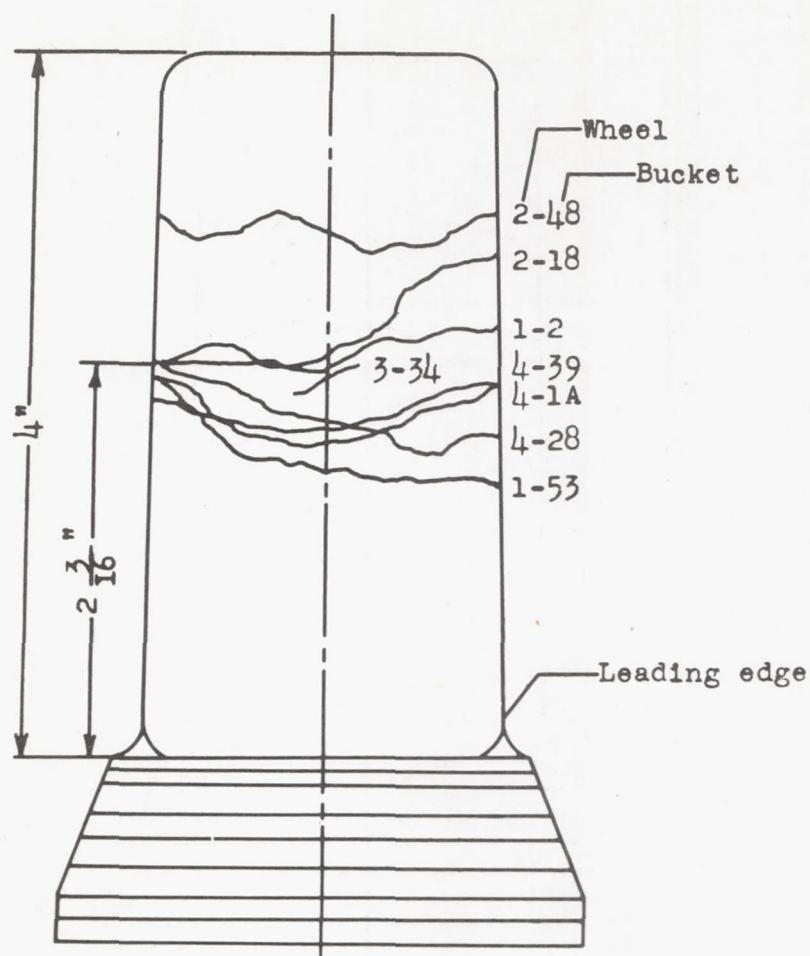
(a) Failures caused by fatigue.

Figure 9. - Composite profile of failures of cast Vitallium turbine buckets.

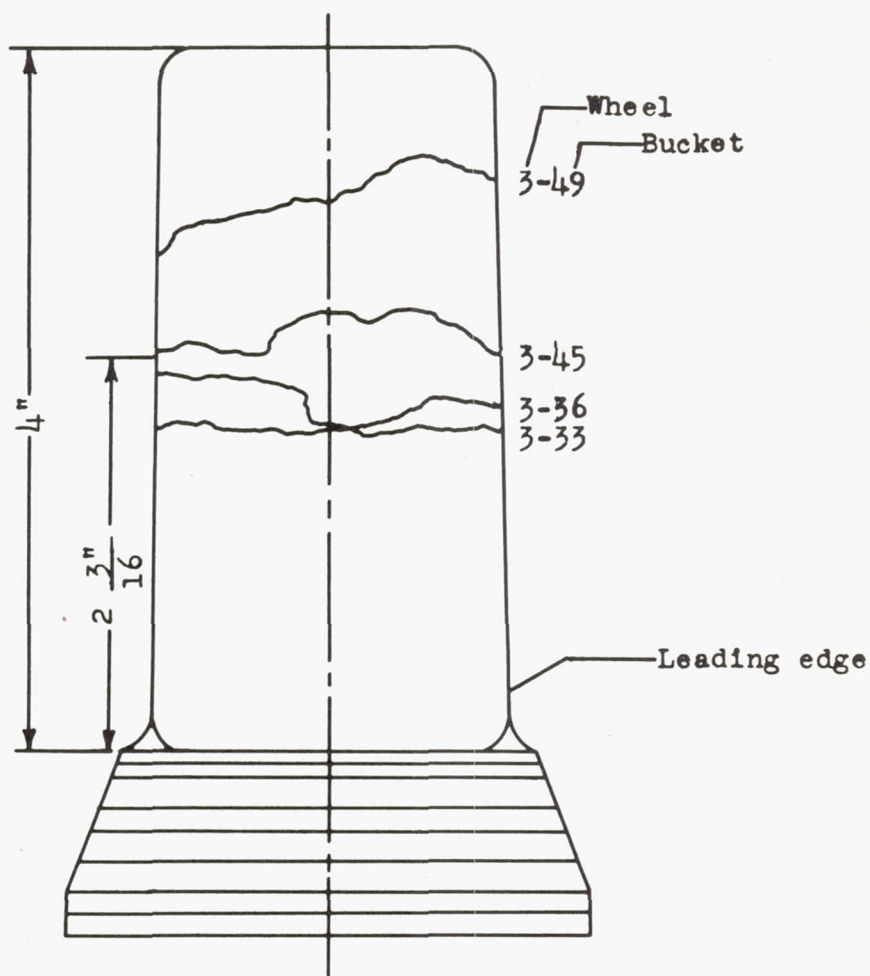
(b) Failures probably caused by impact.

Figure 9. - Concluded. Composite profile of failures of cast Vitallium turbine buckets.
